CASE STUDY | PETROCHEMICAL | BOILER FEED WATER

How Alpont Methanol Stopped Replacing Boiler Feed Water Orifice Plates Every Three Months

An engineering case study from Restrict Flow LLC. The Anti-Cavitate Orifice Plate™ in AL6XN super austenitic stainless steel absorbs 740 PSI of differential pressure across one device, ending a multi year cycle of unplanned plant shutdowns at a methanol production facility.

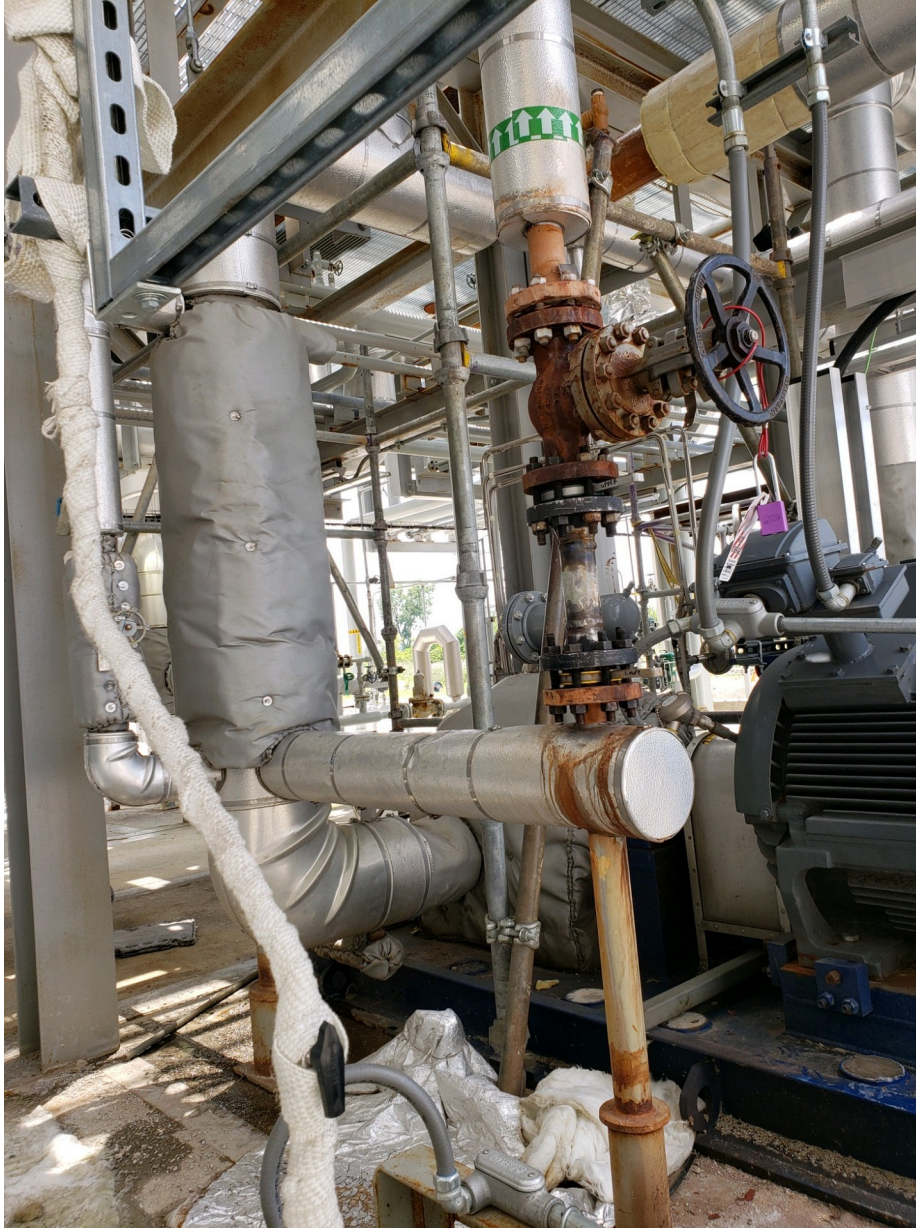
BFW Pump A discharge piping at Alpont Methanol's Oregon, Ohio facility, photographed during the period when the original multi stage configuration was in service. Two standard restriction orifice plates were installed in series in the upper and lower flange sets visible above the pump motor. Plate failures in this configuration drove a quarterly cycle of unplanned plant shutdowns.

The legacy BFW pump discharge used two standard flat restriction orifice plates installed in series, separated by a vertical pipe spool. The plates were 1/2 inch thick T316L stainless steel, designed for 2 inch Schedule 40 pipe in a 600# RF SW flange set. Each plate was sized to carry a portion of the total pressure drop, with the spool between them allowing some pressure

recovery before the second plate. A 90 degree elbow sat upstream of the arrangement, an isolation valve sat downstream.

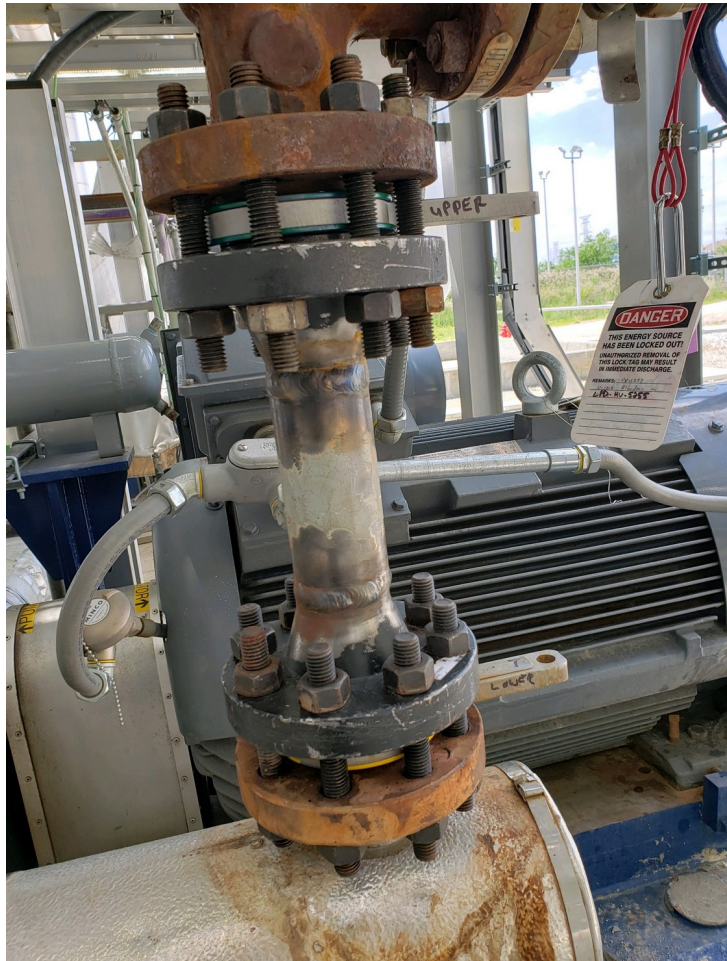
BFW Pump A discharge piping isolated and locked out for one of many quarterly orifice plate replacements under the original multi stage configuration. The DANGER LOTO tag and the UPPER and LOWER flange identification tags marked a procedure that recurred every three months for several years.

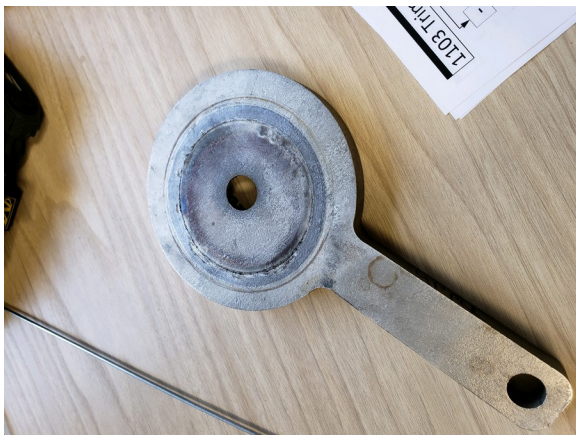
One face: continuous wear across the surface. The bore is still mostly defined.

The plate began as a standard 1/2 inch thick T316L stainless steel orifice with a 0.6296 inch precision bore, mill finish, and a 600# rating. Both faces show wear from continuous cavitation exposure. One face has been violently destroyed at the bore. The handle stamping is still legible. The functional part of the plate is gone.

The wear pattern is a textbook presentation of cavitation in the region between two staged plates. As fluid passes the first plate, pressure recovers along the connecting pipe spool. Any vapor bubbles formed at the first plate's vena contracta collapse against the pipe wall and the upstream face of the second plate. The high velocity microjets produced by those collapses cut into stainless steel like sandblasting, with damage that compounds at every cycle.

In multi stage flat plate configurations under high differential pressure, the space between the plates is exactly where the worst cavitation damage occurs. The Alpont system was performing as designed thermodynamically. The pressure drop was being achieved. The system was sacrificing material integrity to do it, and the bill came due every three months.

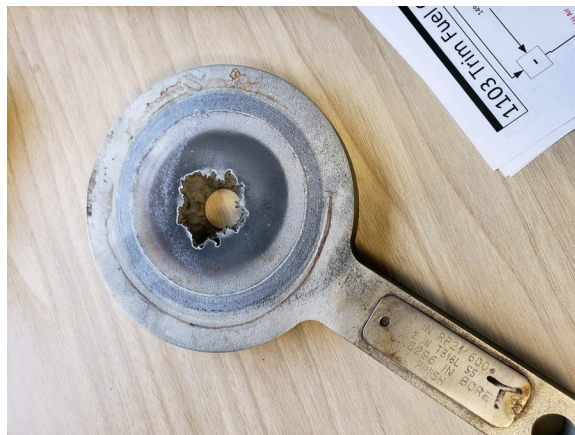
The opposite face: violent destruction at the bore from cavitation collapse.

This was not gradual wear. This was the failure mode that produced the violent cavitation and downstream noise the operations team learned to recognize as the signal that another shutdown was coming. Once the bore opens up, flow accelerates, cavitation intensifies, and the failure cascades. The plate goes from working to wasted in a window measured in hours.

The choice of metallurgy contributed to the failure cycle. Type 316L stainless steel is a reasonable default for general process piping, but it is not always sufficient for high pH BFW service at elevated temperature, particularly when there is active cavitation to expose fresh metal surfaces.

Cavitation erosion is mechanical, but the freshly exposed metal it creates is immediately vulnerable to chemical attack. In a high pH, high purity water environment with continuous flow

at 190 °F, even trace chloride exposure can initiate pitting and crevice corrosion in 304 and 316 stainless. The combined mechanism accelerates failure rates well beyond what either pure cavitation or pure corrosion would produce alone.

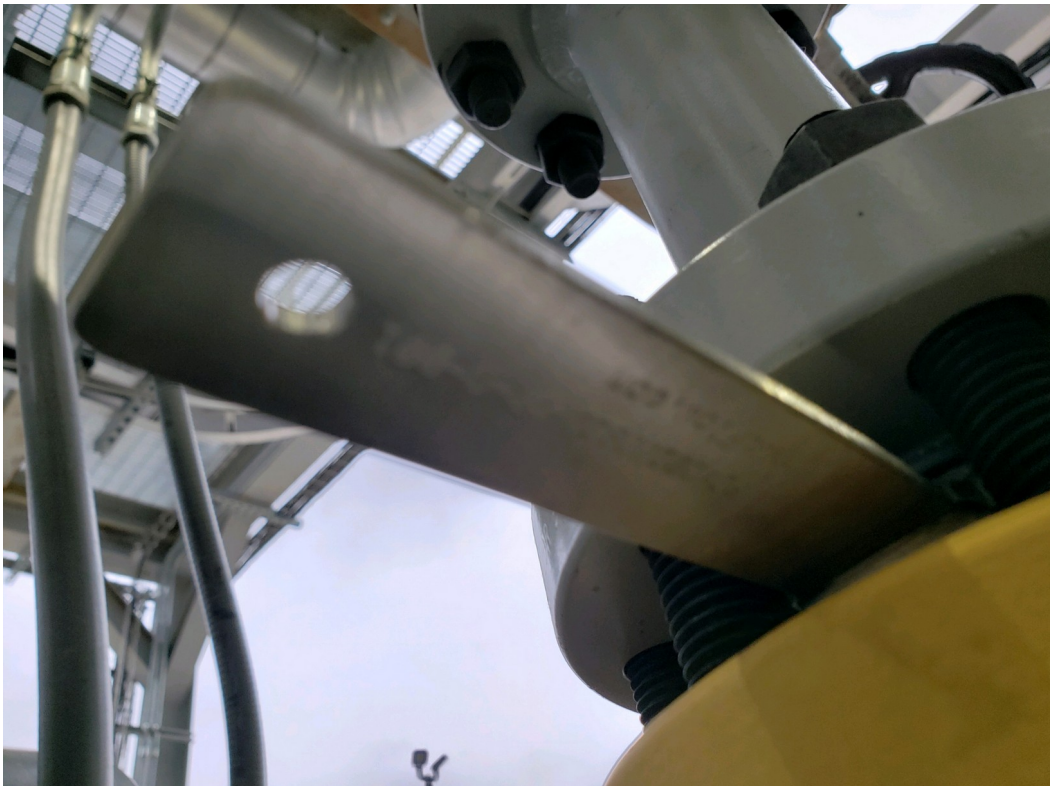
The Anti-Cavitate Orifice Plate™ in service at Alpont Methanol, installed in the lower flange position. Only the handle is visible from outside the piping. The plate body absorbs the 740 PSI pressure differential between the flange faces.

The Anti-Cavitate Orifice Plate™ was installed in August 2020 in the lower flange position of the BFW Pump A discharge piping. The previous upper flange position, which had held the second of the two original standard plates, was filled with a spacer to maintain the original pipe geometry without modification. Per Restrict Flow's design guidance, the engineered profile of the plate faces upstream and the handle is installed with the INLET marking visible on the upstream side. The customer's millwright crew handled the physical installation. Restrict Flow's engineering team provided installation guidance and confirmed handle orientation and flange torque pattern before the system was returned to service.

Flow development was a meaningful part of the engineering conversation. The ideal installation location for any restriction orifice plate is in a straight run of pipe, with 6 to 12 pipe diameters of clear length both upstream and downstream of the plate. Elbows, valves, and other flow disturbances within that envelope can degrade plate performance for any restriction orifice technology.

The Alpont piping geometry did not allow for ideal flow development on both sides of the plate. The choice was where to put it: the upper flange position, immediately below the isolation valve, or the lower flange position, immediately above the 90 degree elbow at the pump discharge. The lower position was selected. Cavitation behavior is determined primarily by what happens downstream of the orifice as pressure recovers, and the lower position gives the fluid the longest available run of clean vertical pipe to reconstitute its flow profile after passing through the device. The full pipe spool that previously sat between the two original standard plates now serves as downstream flow development space.

The Anti-Cavitate Orifice Plate™ showed only minor surface discoloration consistent with normal exposure to treated BFW at 190 °F. No measurable erosion. No detectable wear. No evidence of cavitation damage on either upstream or downstream faces. The handle markings remained legible. The plate was returned to service with no remediation required.
